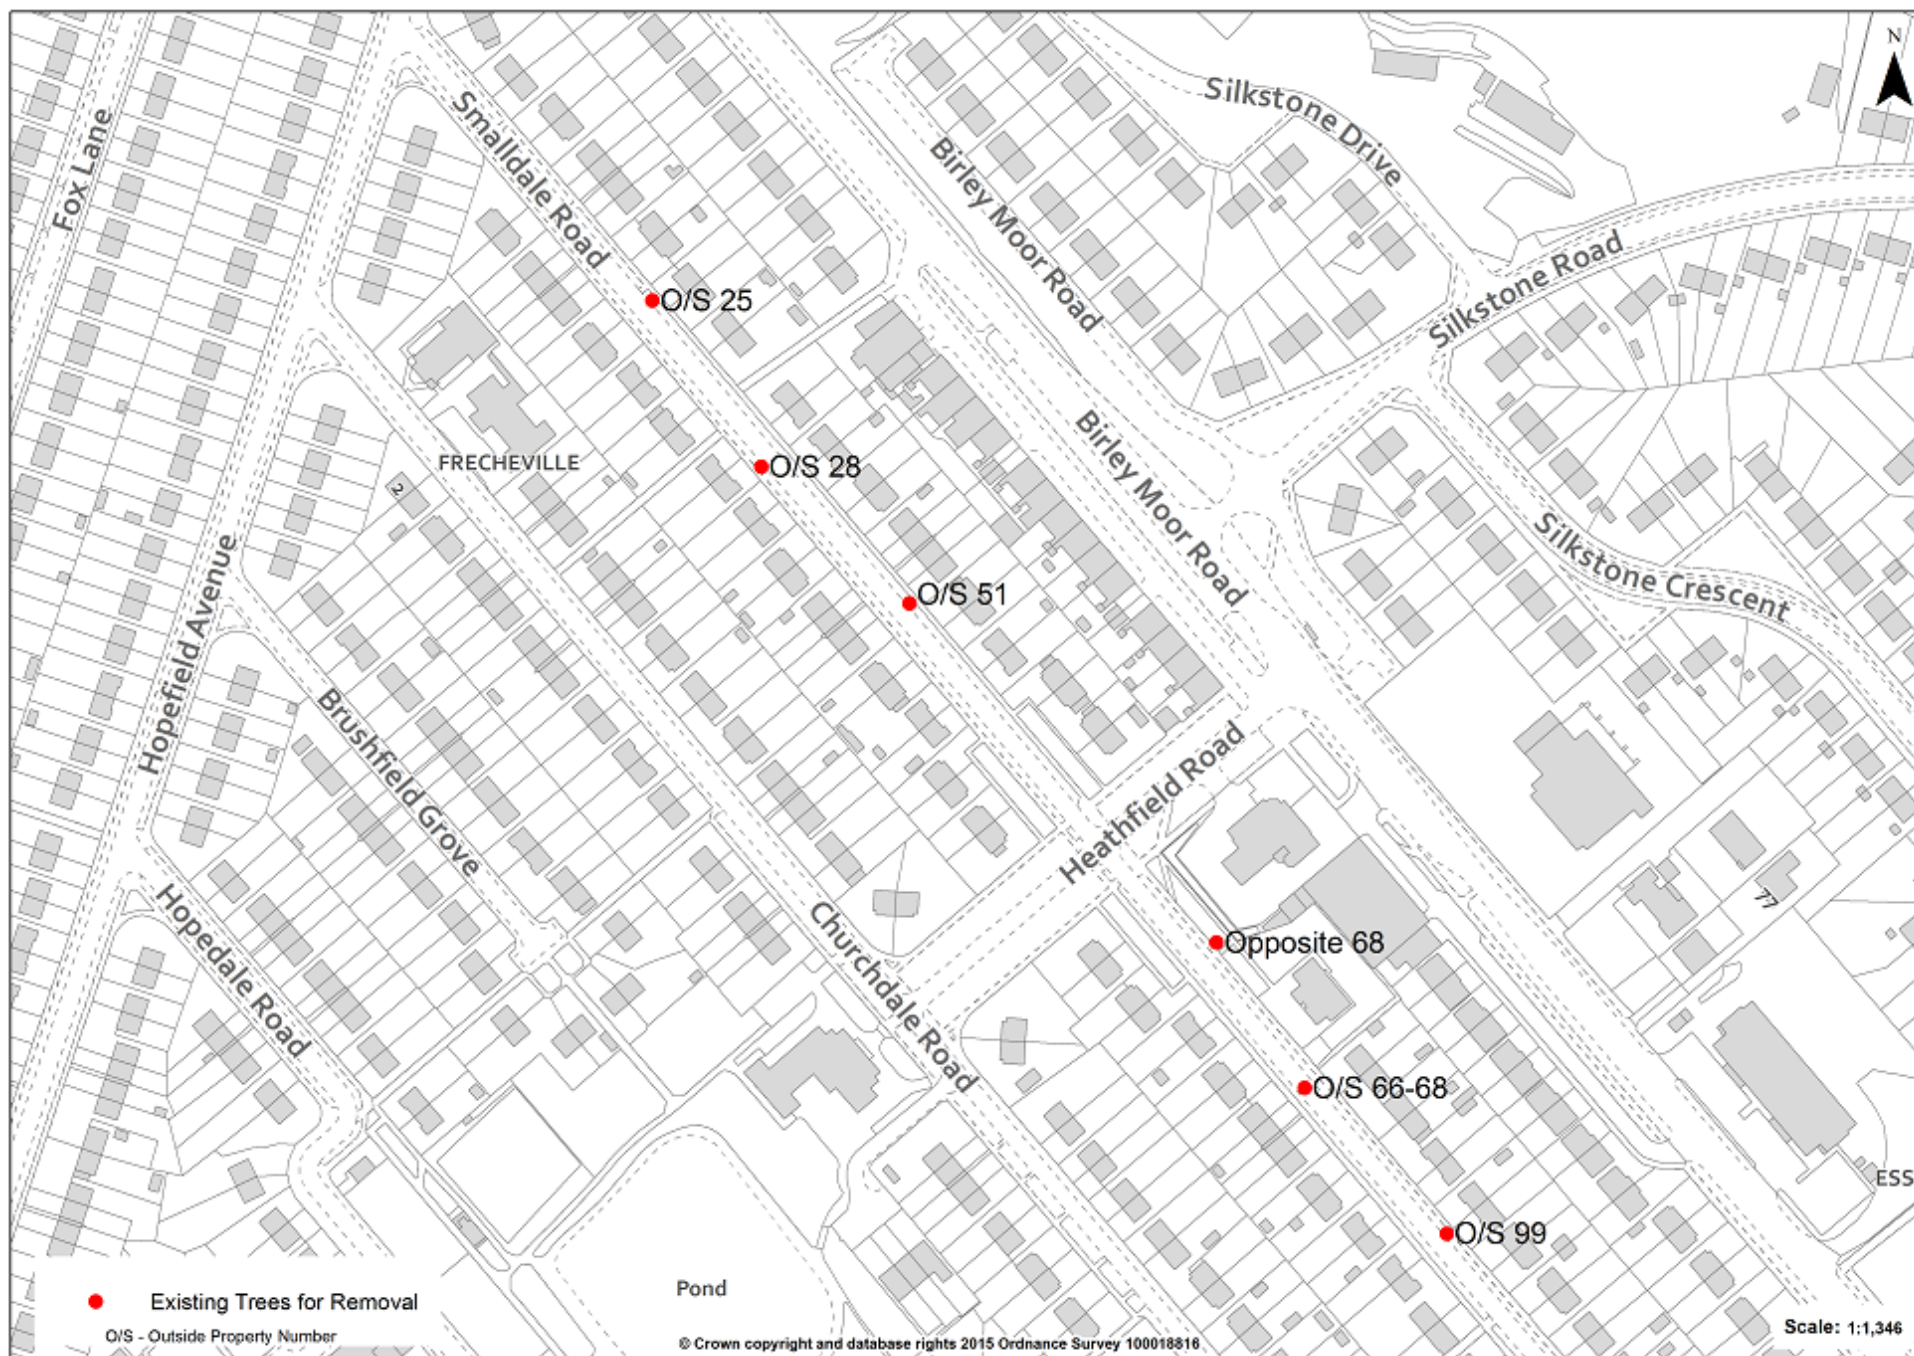
Site Name	Feature Location	6 D's	Reasons	Existing species	Planting notes	Replant species
SMALLDALE ROAD	o/s 66-68	Dangerous	TR: Felling; Fell and grind Ast tree, in grass verge o/s the property. In decline poor unions and causing damage to the footpath. - Topped in past, of no value at all.	Fraxinus excelsior	OS number 68 smalldale road	TR: Planting. Acer campestre 'Elegant'
SMALLDALE ROAD	o/s 28	Dangerous	Structural Integrity - Pseudomonas syringae infected, limite/less than 10 year safe useful life expectancy remaining.	Aesculus hippocastanum	o/s 28 in verge	TR: Replanting- Betula ermanii
SMALLDALE ROAD	o/s 25	Dangerous	F/W uplifted/cracked, Pseudomonas syringae infected also	Aesculus hippocastanum	Plant in verge between 25/27	TR: Planting, Betula ermanii
SMALLDALE ROAD	o/s 51	Damaging	Rooting into carriageway and historic root severnce, safe retention in doubt.	Betula pubescens	Plant in verge between 49-51	TR: Replanting- Betula ermanii

SMALLDALE ROAD	opposite 68	Damaging	Extensive f/w mounding	Fraxinus excelsior	Plant in verge opposite 64	Betula ermanii (TR: Replanting)
SMALLDALE ROAD	o/s 99	Damaging	Partial root severence suspected by highway engineers and implicated in a claim for damage to the boundary wall. - Partial root severence suspected by highway engineers and implicated in a claim for damage to the boundary wall.	Acer pseudoplatanus	In verge between 97-99.	TR: Replanting- Acer campestre 'Louisa Red Shi -
SMALLDALE ROAD	Junction with Hopefield avenue. Triangular verge.	No Tree to remove	Tree historically removed	Whole Tree Feature	Junction with Hopefield avenue. Triangular verge.	Prunus 'Umineko'
